The 7th Jordanian Int. Civil Eng. Conference

Site Investigations, Treatments, and Construction Regulations in Landslide-Prone Areas in Jordan

Prof. Dr. Yousef Masannat, yousef.april@yahoo.com

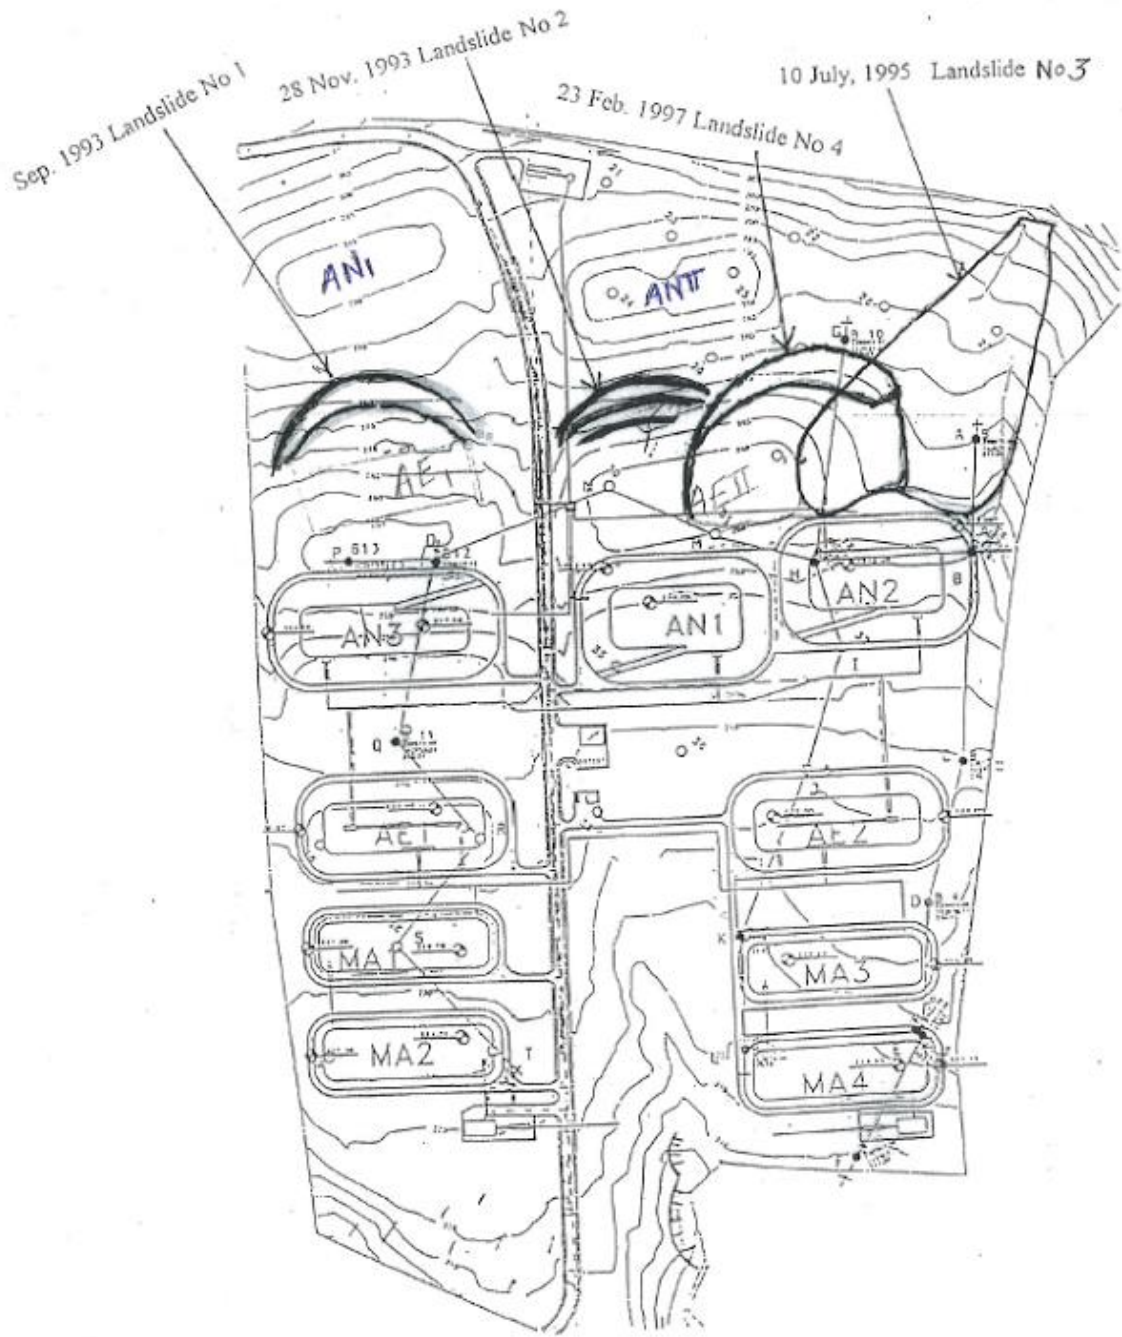
The investigation works that were carried out in February, 1994³ showed that the sliding surface passed through a weak layer of loose colluvium and that the slopes were cut at angles that were too steep for such a weak layer particularly under the conditions of high saturation. Reports issued after further investigations recommended the cancellation of some lagoons, shifting of some lagoons further down the slope, flattening the slopes, and the provision of effective drainage system. Although some of the lagoons were shifted to other locations and the slopes were flattened to 4H: 1V many landslides occurred in the period from September, 1993 till February, 1997 as shown in Figure (1).

Figure (1). Approximate locations of the four landslides
(WESTP)

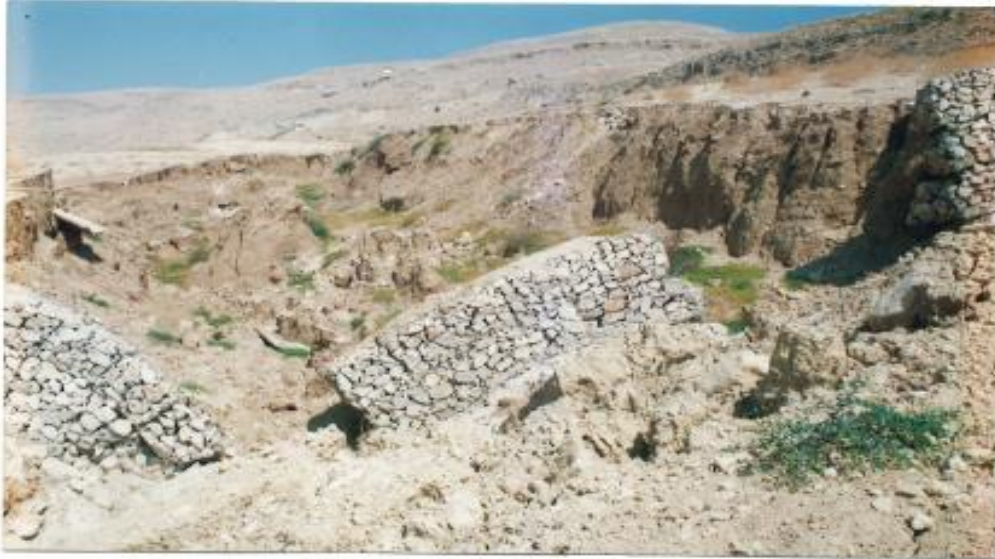
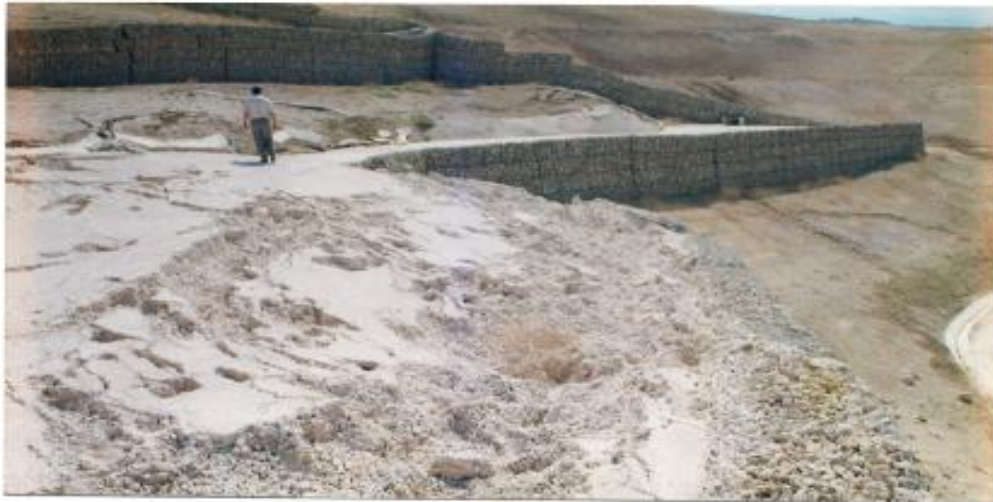
The geological and geomorphological features of the area clearly indicate that it suffered from many old landslides. The poor surface and subsurface drainage conditions had further contributed to the instability of cut slopes. Figures (2, 3) show the consequences of the last landslide resulting in the partial failure and displacement of the gabion wall at the toe of the slope and the breaking down of the gabion on the northwestern side of the cut slope. Had adequate site investigations been carried out the site would have been deemed inappropriate for the construction of the plant.

Figures 2, 3 show the breaking down of the side gabion wall (top) and the tilting displacement of part of the gabion wall at the toe of the cut slope (bottom) at WESTP

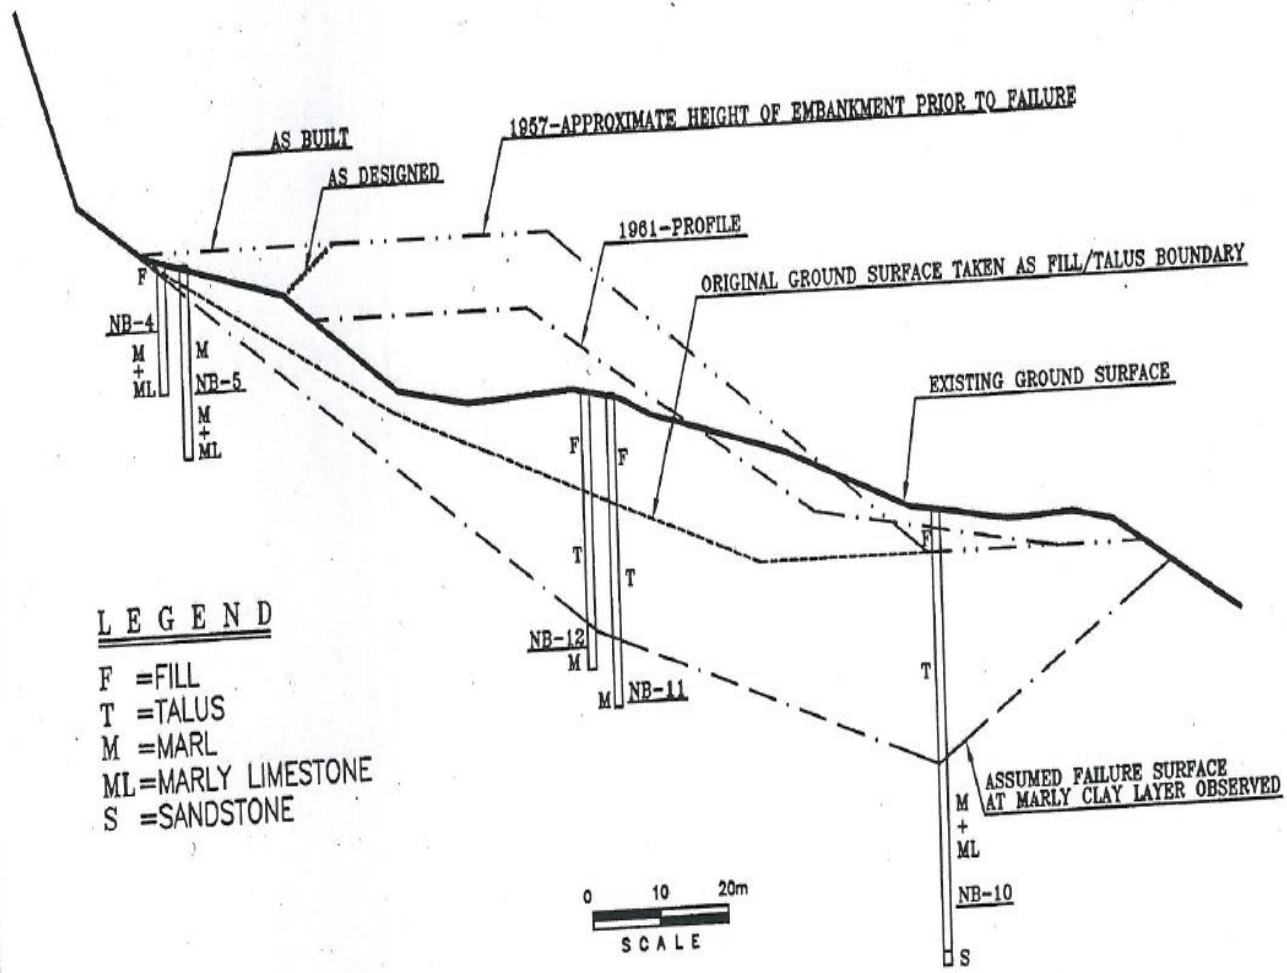
The Amman-Naur-Dead Sea highway was constructed in 1956. Section 3 of this highway crosses what was designated later as landslide No. 4. Several embankment failures (Figure 4) occurred between 1956 and 1964 in this area. It was open to traffic from 1958 to 1964, but was abandoned after the 1964 slide. After many phases of site investigations the Ministry of Public Works decided to pass the highway through a route at a higher elevation which was later designated as the “Upper Alignment” without carrying out adequate site investigations along this new alignment⁴. Many landslides occurred along this new route due to the presence of plastic clayey marls and perched water at different levels. This resulted in a substantial increase in the cost of construction and in a considerable delay in the completion of the works.

The extensive investigation works carried out at the “Lower Alignment” indicated that the strata were inclined favorably into the slope. During the construction of the highway along the adopted “Upper Alignment” the dip of the strata changed in the further stations in the unfavorable orientation out of the slope which further contributed to the instability of the cut slopes.

Figure 4. CROSS SECTION OF LANDSLIDE No.4
 ST. 10+300
 (REF. 4)

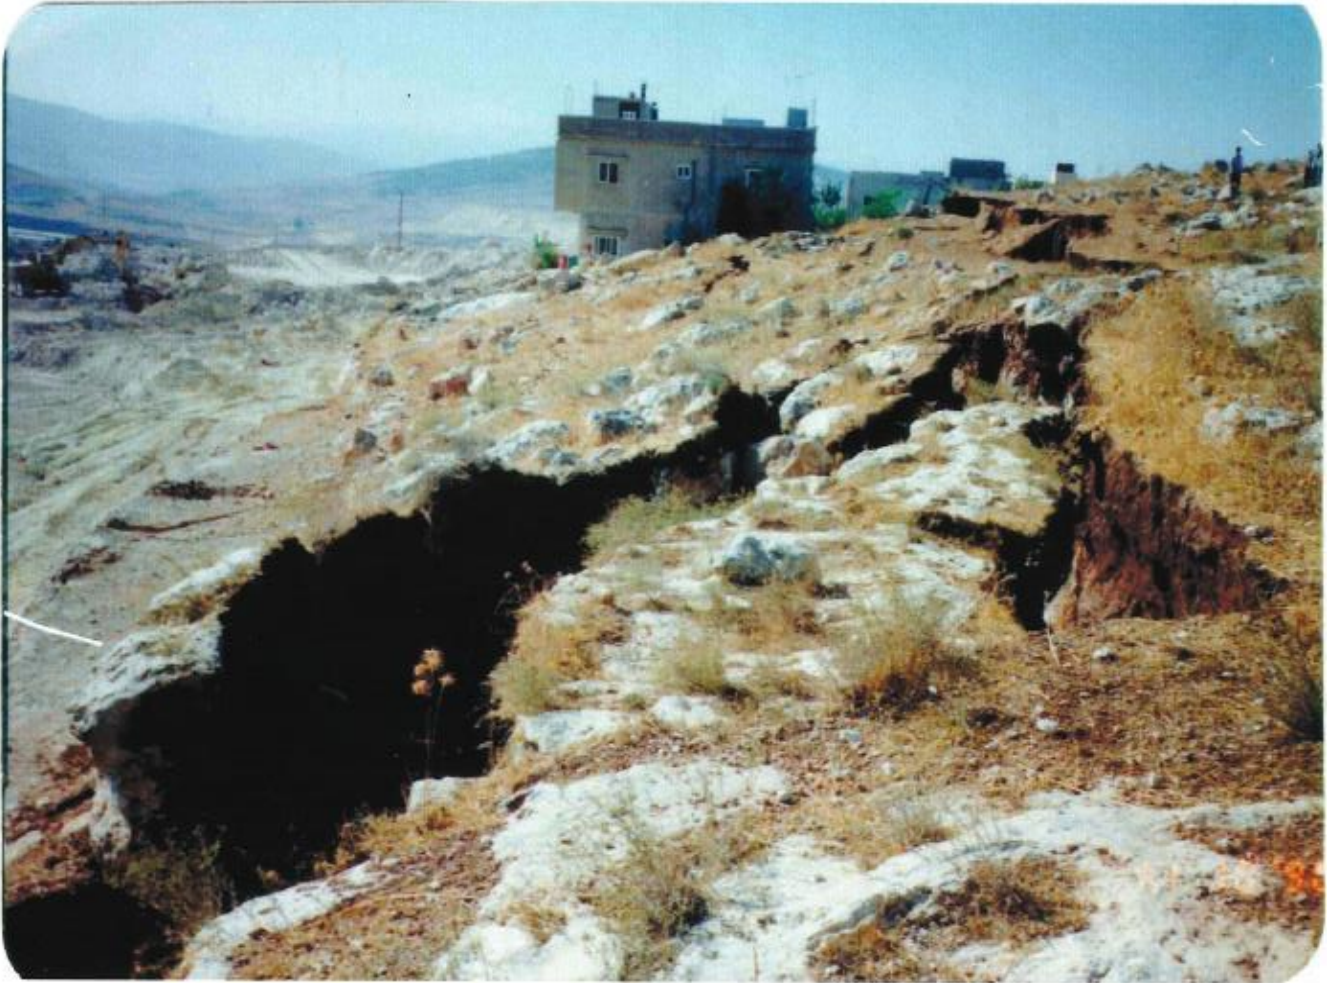
1. The presence of intercalations of weak and water-sensitive plastic layers within the slope materials like the shale beds within the Kurnub Sandstone Formation (L. Cretaceous) and clayey marls within the lower Ajloun Group (U. Cretaceous).
2. The poor surface and subsurface drainage conditions that led to the deep percolation of rain water within the slope materials and the softening of the argillaceous beds of shale and marl.
3. The daylighting of the wet shale and marl beds with unfavorable dip orientation during the excavation at the toe of slopes that were in a precarious state of stability (Figure 5).
4. The placements of high embankment fill on colluvial deposits that were existing in a critical stability condition.

Figure 5. Failures along Jerash- Irbid highway due to daylighting of wet plastic marls.

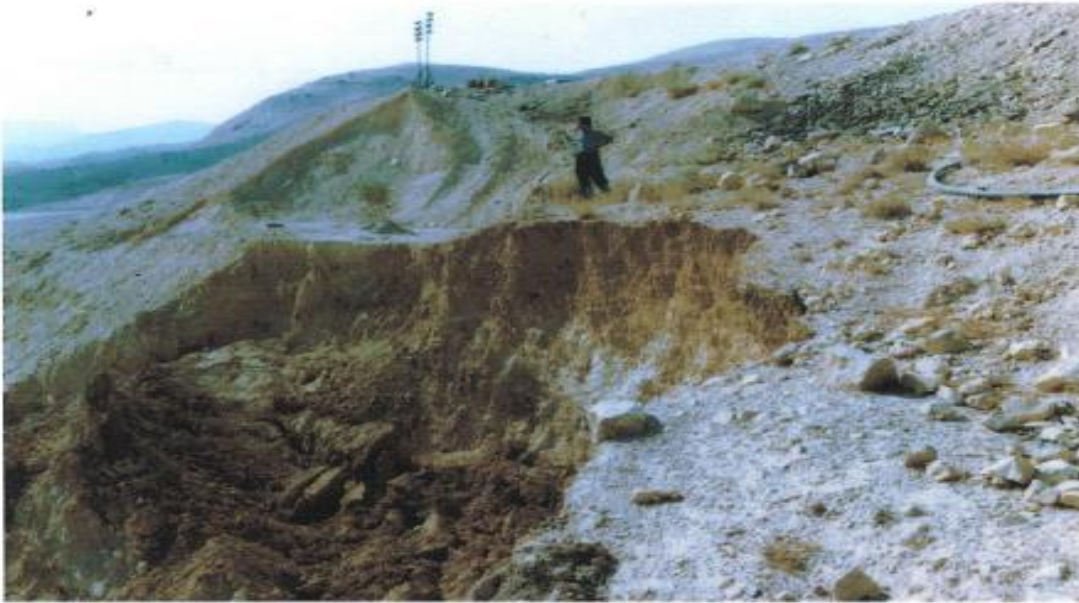
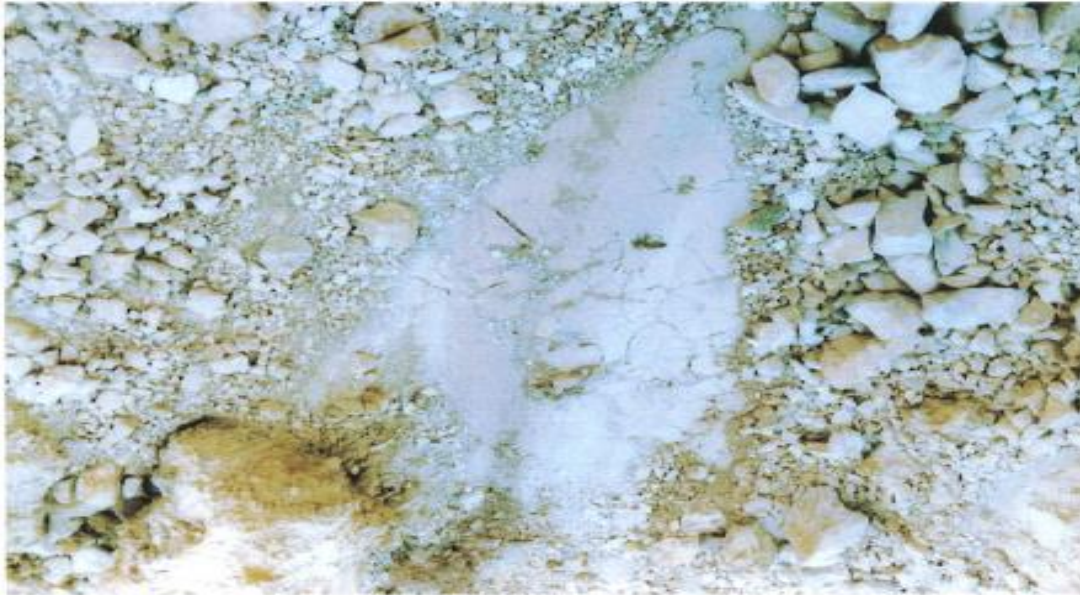
During the excavation at the left abutment of the roller compacted concrete Mujib Dam an unexpected landslide occurred that prompted the designer to shift the axis of the dam downstream of its original position. The landslide was due to the daylighting of a moderately thick (about 1.0m) wet plastic mudstone layer overlain by loose colluvium that allowed percolation of rainwater towards the mud layer that was dipping unfavorably out of the cut slope forming a slip surface for the landslide (Figure 6).

Figure 6: A Landslide on the left of abutment of Al – Mujib dam.

A) The escarpment of the slide in the talus material.

B) The slickenside surface in the underlying mud layer.

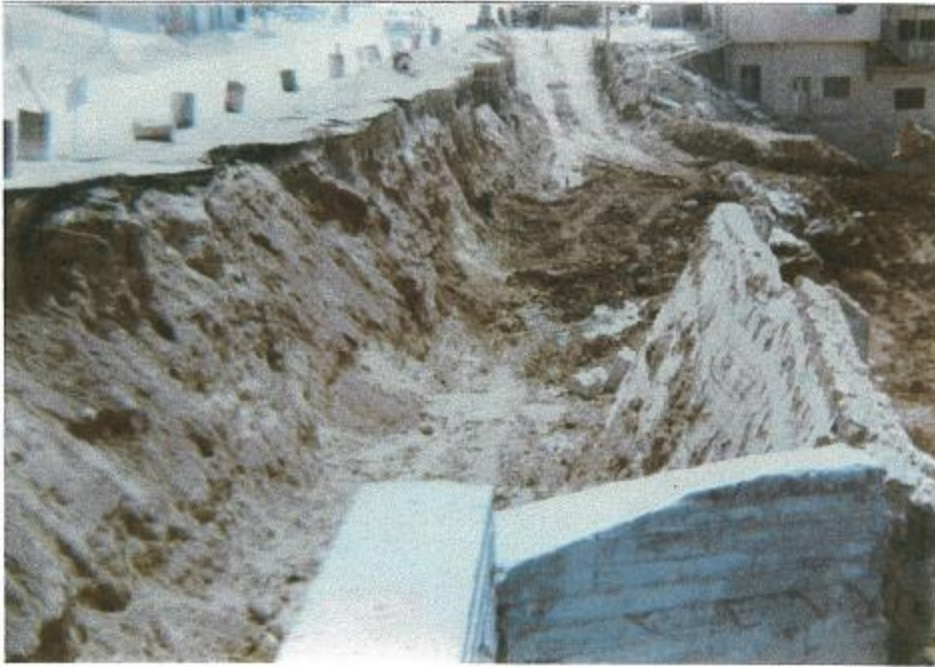
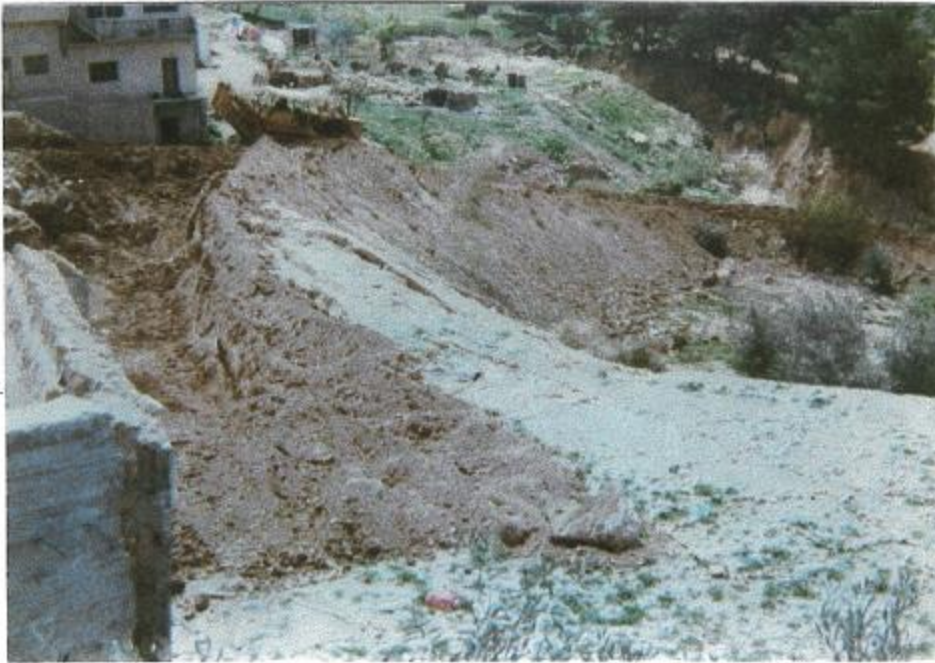
Retaining walls were constructed on the western side of a major street passing through Tafila town near Wadi Zeid. During the first winter season after their construction the retaining walls failed by tilting and excessive displacement down the slope. Post-failure investigations indicated that the failure was due to the low bearing capacity of the wet plastic clayey marls on which the retaining walls were founded and to the poor drainage condition and the poor quality of the backfill materials behind the retaining walls.(Figure 7).

Figure 7. (a)The displacement and overturning of retainig wall on wadi Zied in Tafila

(b) The displacement of slope material beyond the failed wall.

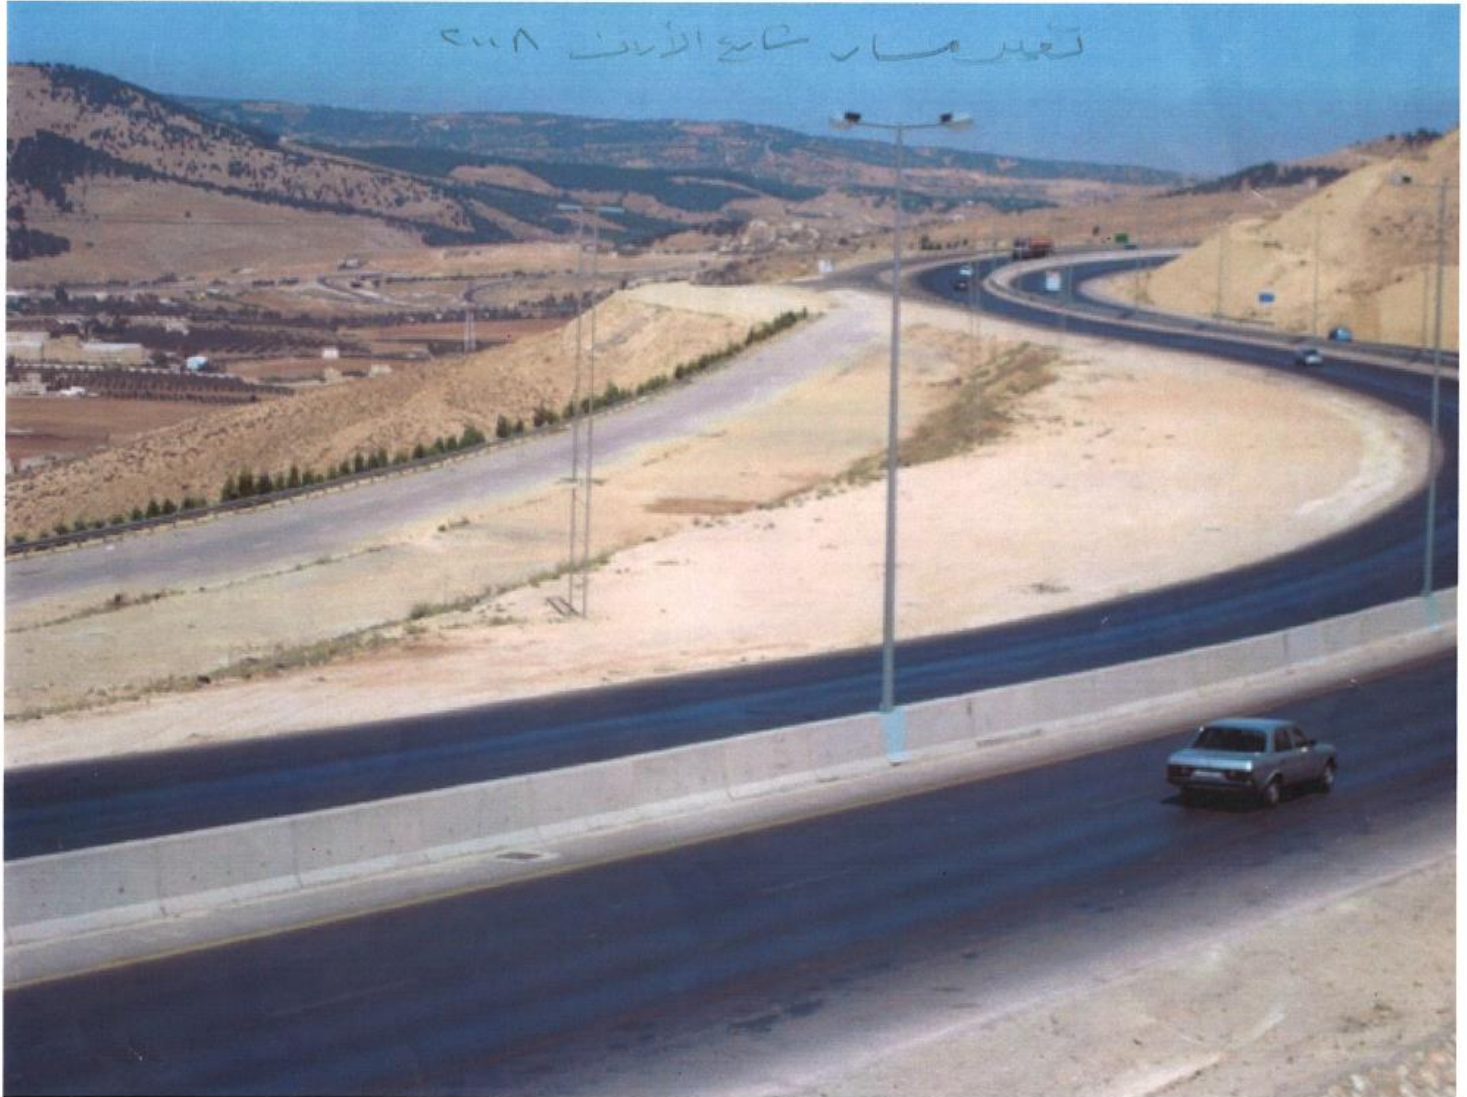
After constructing the Jordan Street at a zone few kilometers before the link with Sweileh- Jerash highway creep movement resulted in the subsidence and cracking of the asphalt surface of the highway. Investigations indicated that the creep movement was due to the placement of high fill on a pre-existing slip surface passing through moist plastic marl in an area that suffered from an old landslide.

The geomorphological features and the inverse dip of strata on the eastern side of the road from that on its western side across the nearby wadi clearly indicate that the area suffered from an old landslide.

Figure 8. The shifted section of Jordan Street highway

This creep movement prompted the designer to shift the alignment of the road to a more stable area on the east (Figure 8).

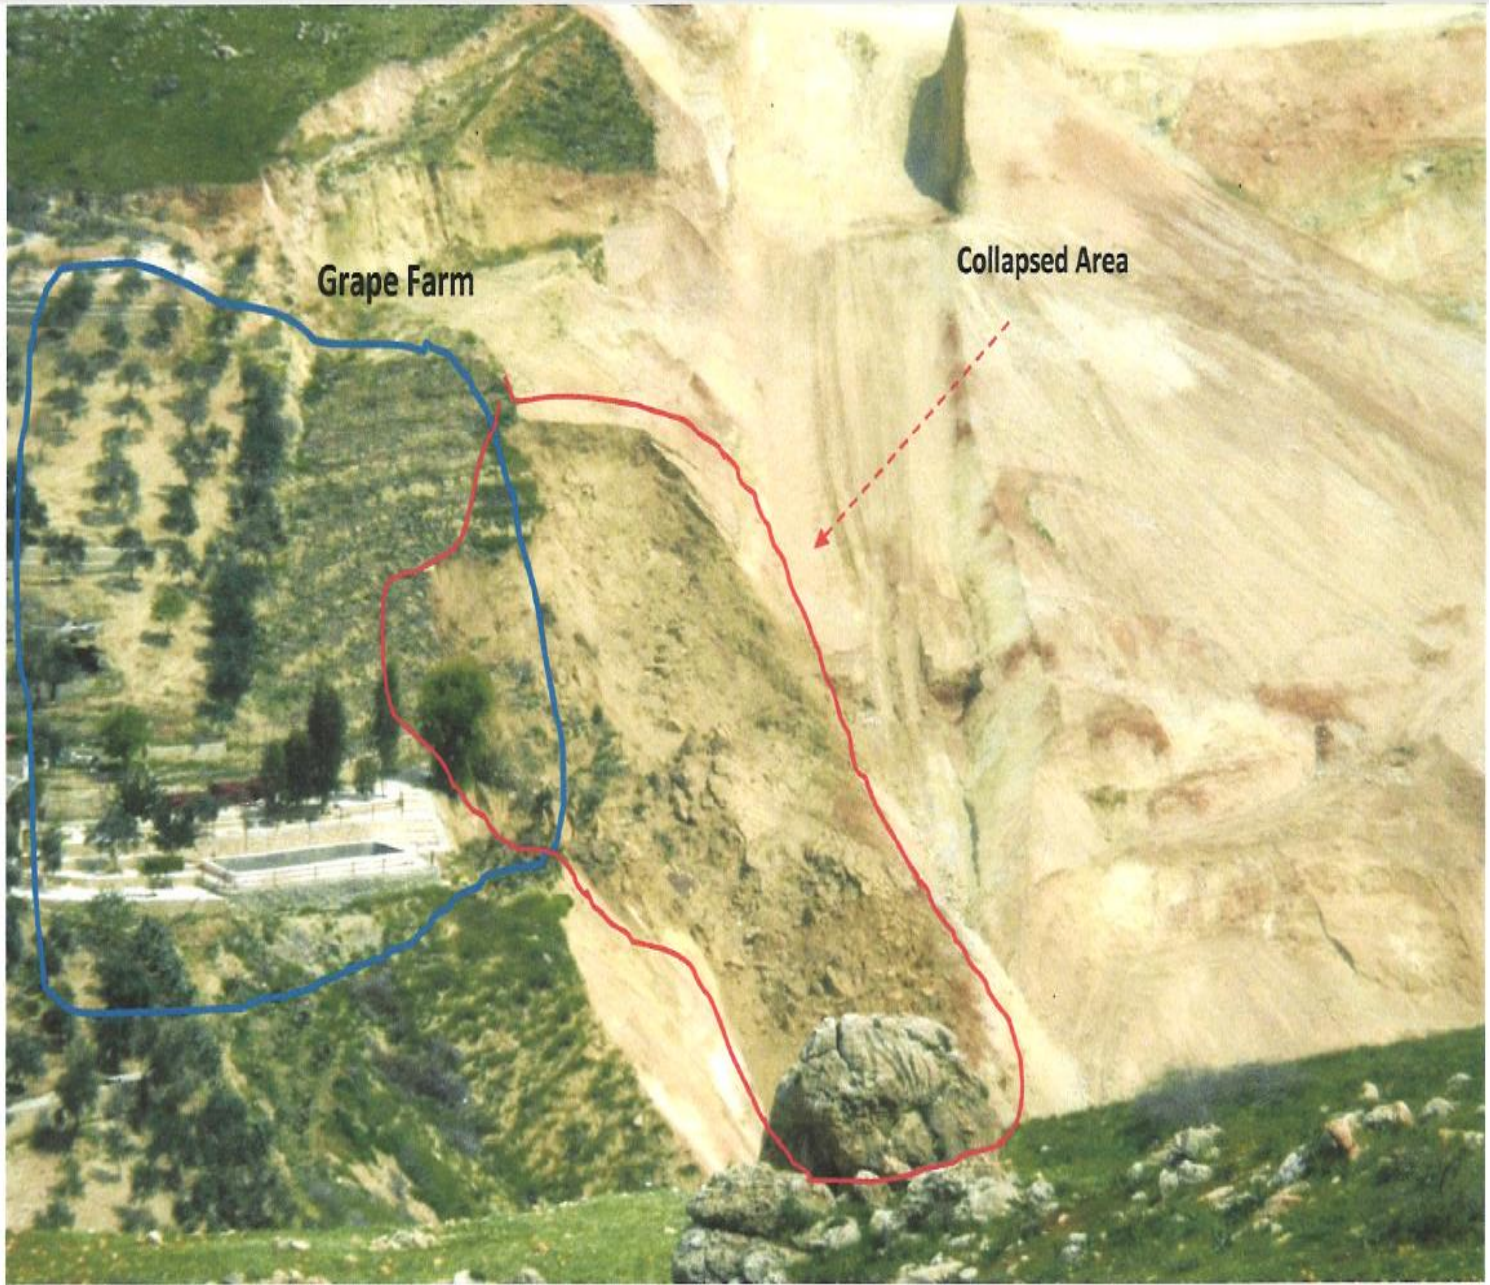
A landslide occurred in the spillway chute of Kufranja Dam on March 17, 2012. Post – failure investigations indicated that the slide was initiated in plastic clayey marl near the middle of the spillway chute that was recently excavated due to the absorption of moisture from the preceding rainy months. The percolated water through the jointed rock mass near the top of the spillway excavation affected the colluvial deposits in the lower zone of the spillway chute. The colluvium was much thicker than what was assumed in the design and the geologic conditions were also worse than the expected ones. Figure 9 shows the spillway chute excavated area after the landslide which resulted in an increase in the cost of the project and delay of its construction.

Figure 9. Excavation of Spillway, Chute and Flip Bucket (31/03/2012)
